EFFICIENT FIELD INSPECTION AND EVALUATION FOR CONCRETE BRIDGE DECK WITH ASPHALT OVERLAY

Structure Research Team

Korea Expressway & Transportation Research Institute

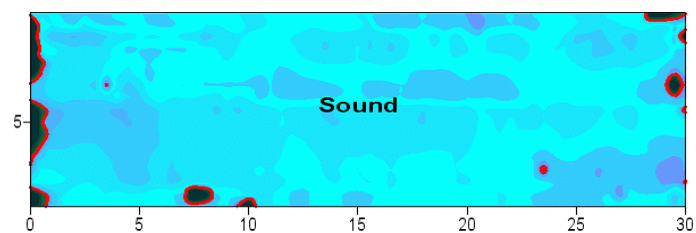
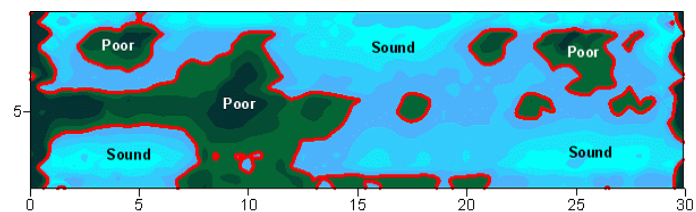
Figure 8 Example maps of relative permittivity of deck concrete under the pavement

deteriorated by freeze-thawing action because there is saturated with water and chemicals according to the damage of overlay and waterproof membrane. The relative permittivity of concrete deck can be obtained by GPR system. Figure 8 shows the result of the GPR survey performed on bridge decks under asphalt overlay. It illustrates the distribution of the relative permittivity of the concrete decks as a plane view. The dark areas in the figure represent the damaged areas which will be or are present.³⁾

(a) Sound deck

(b) Deteriorated deck

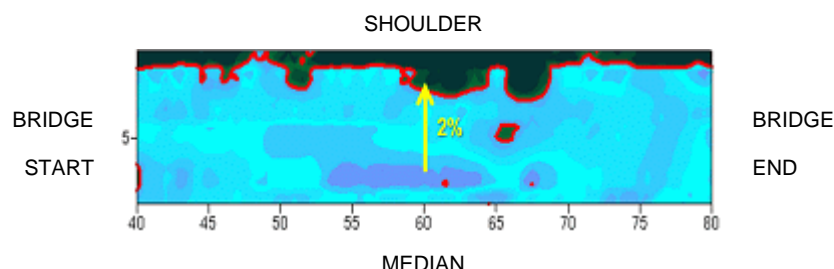
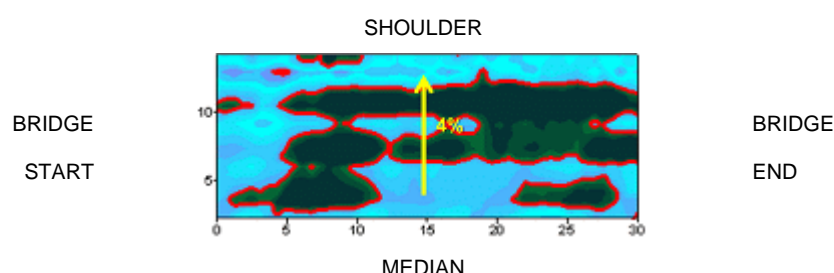
Figure 9 Deterioration tendency according to bridge ages

32 bridge decks inspected in Article 3.1 were inspected and evaluated by GPR system. As the previous inspection, the condition grades were classified according to Table 1. The result showed that deteriorations of young bridge decks start at the locations next to drain gutters where are low in transverse direction and easily have some staying water. On the other hand, the damages of aged bridge decks appeared higher on the 2nd traffic lane where the overlay damage is begun by the repetitious heavy-vehicle loads. In other words, the followings can be told. For preventing the

(a) A bridge on Yeongdong expressway (9yrs old)

(b) A bridge on Kyeongbu expressway (38yrs old)

premature failure of young bridge decks, the draining facilities should be maintained not to have the staying water. And for reducing the deck failure of aged bridges, the preventive maintenance of deck protection member is required to prevent the infiltration of the harmful water and chemicals.

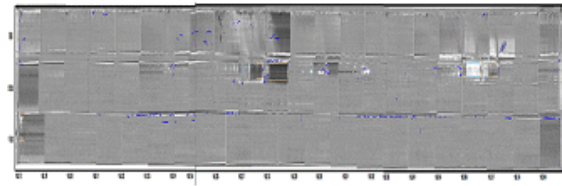
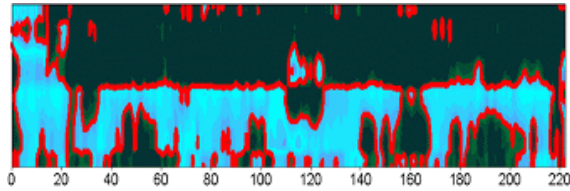
Figure 10 Comparison of survey results of a bridge on Yeongdong expressway

The inspection results described in Article 3.1 and 3.2 is summarized in Table 3. As shown in the table, the most of bridge decks showed a larger deterioration area when inspected with the GPR system than when inspected by visual. For these reasons, the number of bridge decks with the grade "e" by GPR inspection was more than those by visual inspection. In other words, damages of bridge deck under the overlay can be present and progressing without any symptom.

(a) Visual survey (deterioration area : 66m^2)

(b) GPR survey (deterioration area : 952m^2)

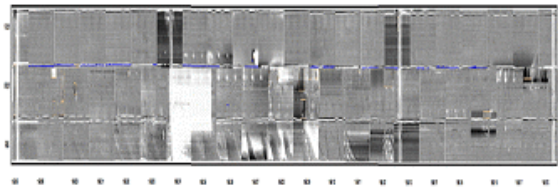
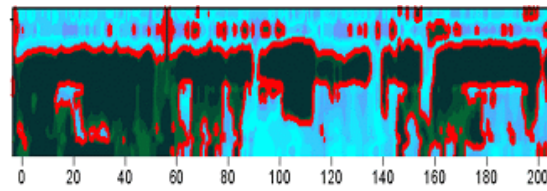
Figure 11 Comparison of survey results of a bridge on Jungbu expressway

(a) Visual survey (deterioration area 96m^2)

(b) GPR survey (deterioration are 864m^2)

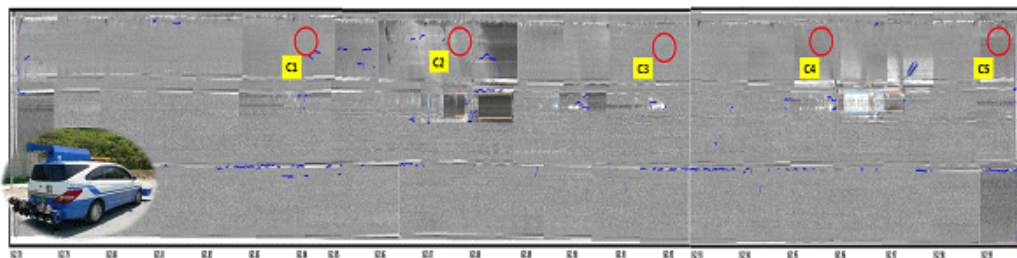
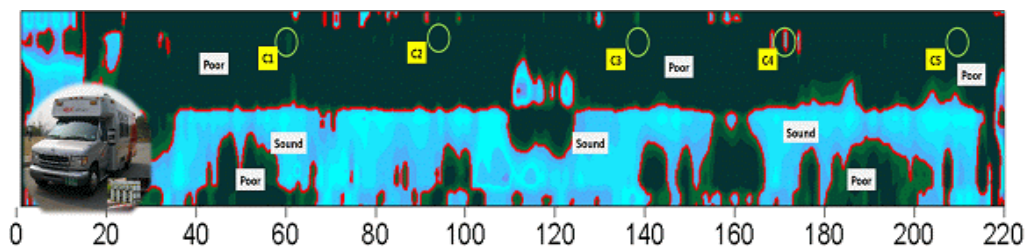
Figure 12 Comparison of survey results of bridge S on Jungbu expressway

Figure 12 and 13 show inspection results of a bridge on Jungbu Expressway. Even though both locations of C1 and C2 had the good appearances, GPR system showed results corresponding to the deck truth data. The bridge deck under overlay was deteriorated at C2 but not at C1.

(a) Visual survey (deterioration area 66m^2 , rate 3%)

(b) GPR survey (deterioration area 1148m_2 , rate 61%)

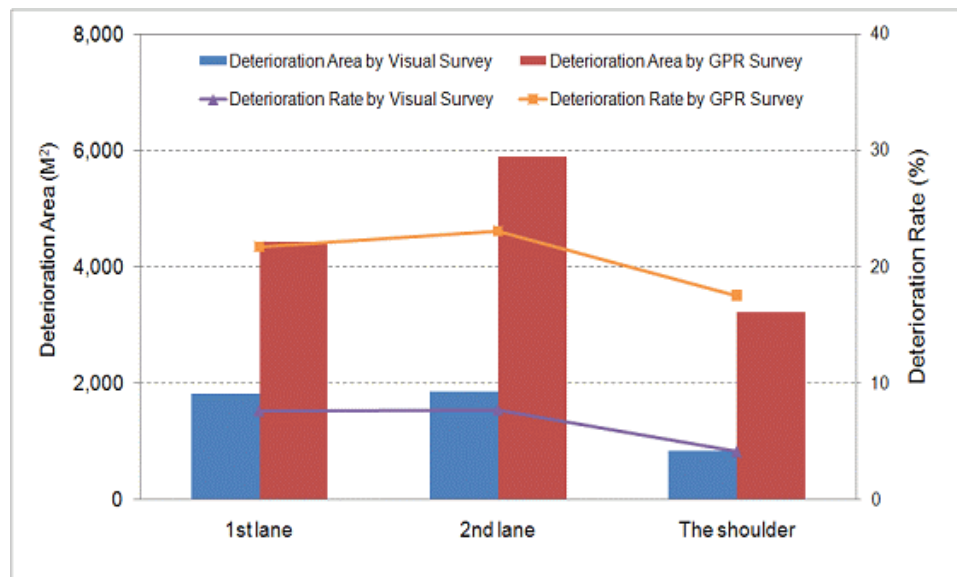
Figure 14 Comparison of deterioration for each lane

Figure 14 shows the deterioration rate by both of visual survey and GPR survey. Both show that the deterioration rate was relatively high on the 2nd lane where the heavy vehicles frequently pass over.
